Architectural Survey of Pershing Elementary School, Fort Leonard Wood, Missouri

Sunny E. Adams and Adam D. Smith

August 2013

Final Report

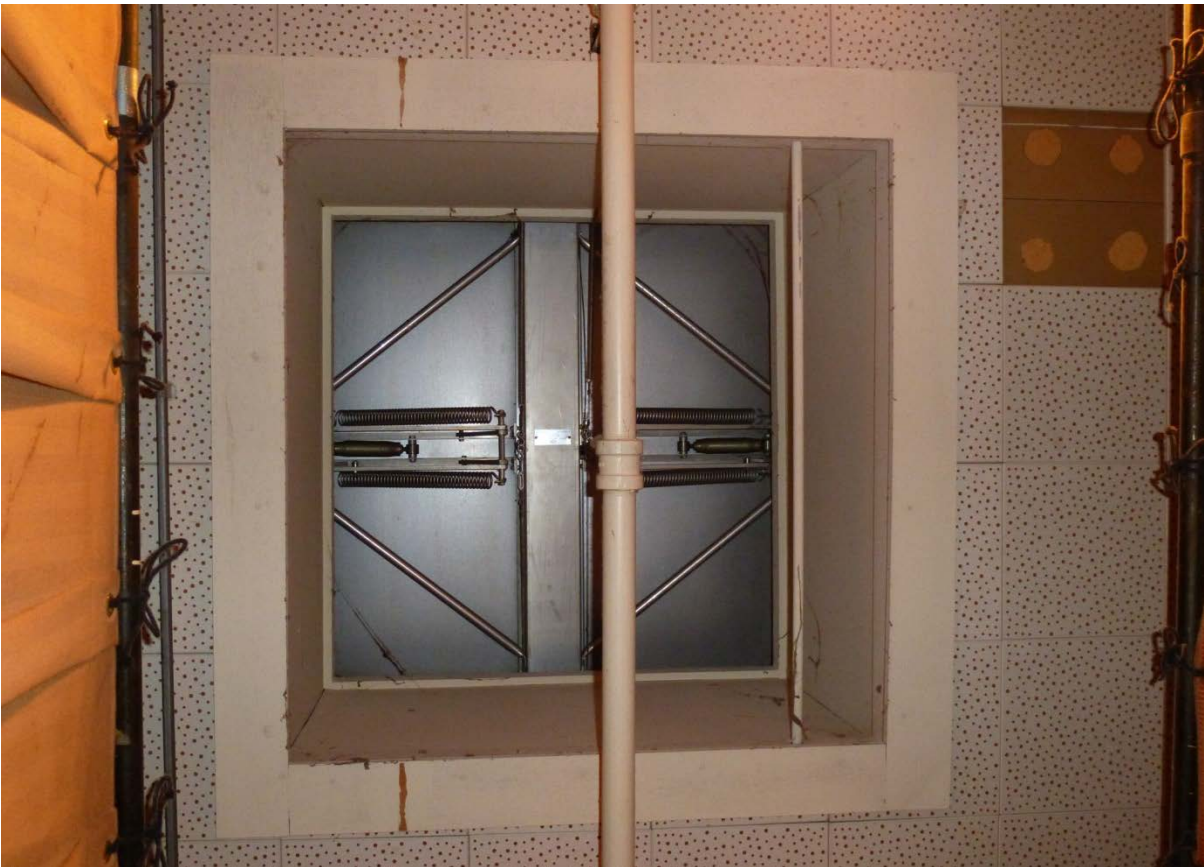
Photo 64. Looking up at original light dome located above the stage (original school) (ERDC-CERL, 2012).

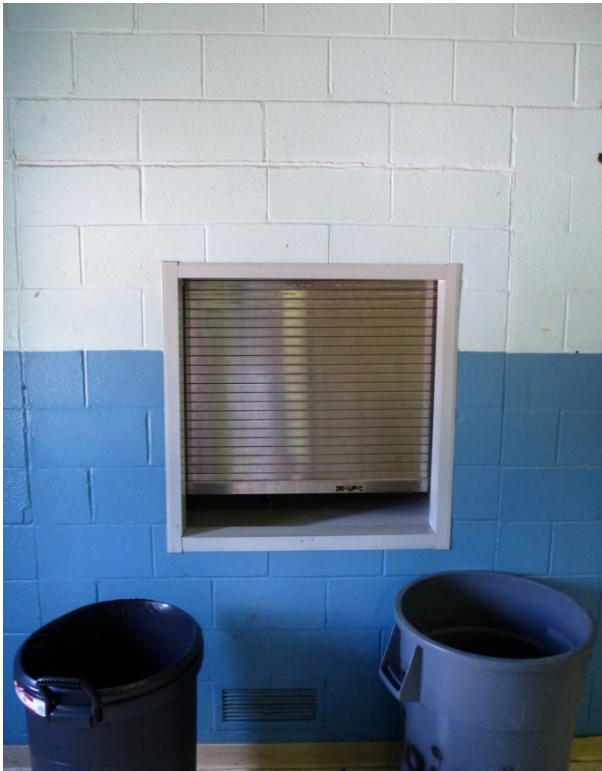
Photo 67. Original door opening filled in with concrete block and small window opening (original school) (ERDC-CERL, 2012).

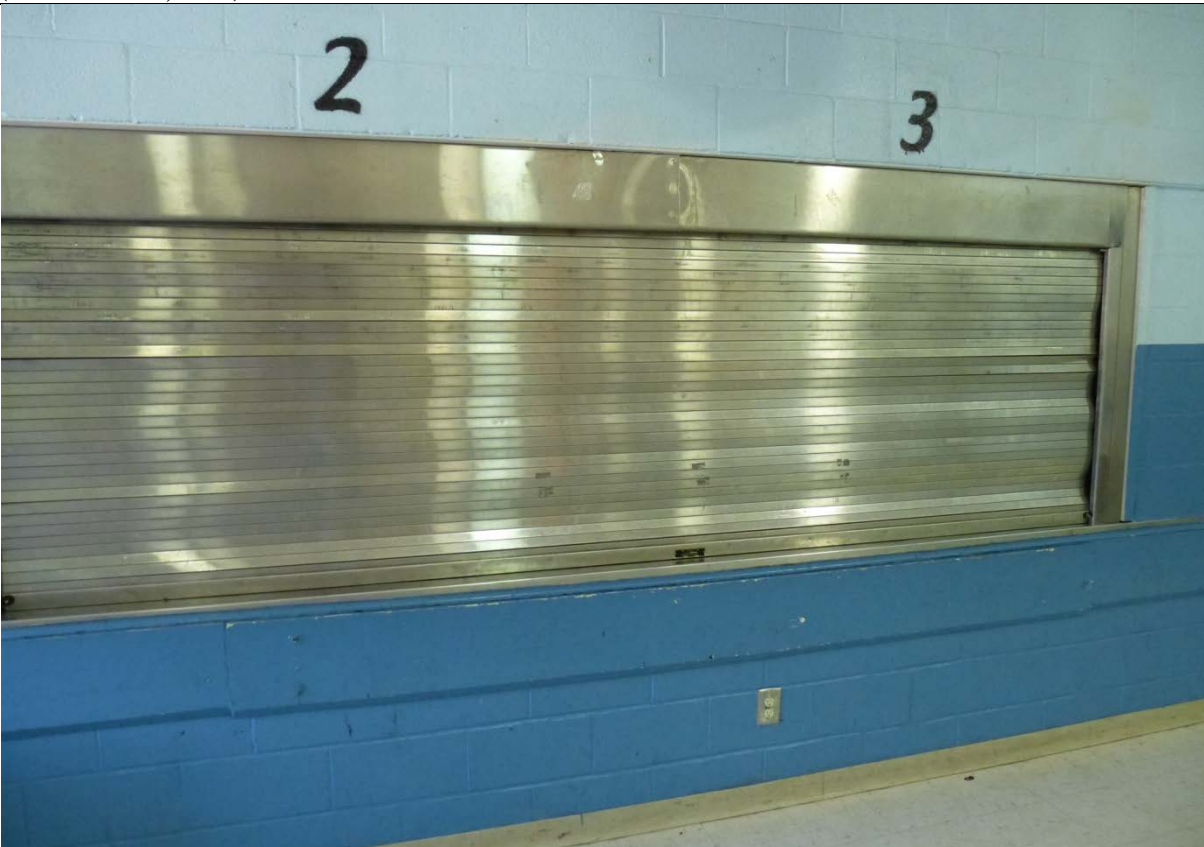
Photo 68. Modified serving line (original school) (ERDC-CERL, 2012).

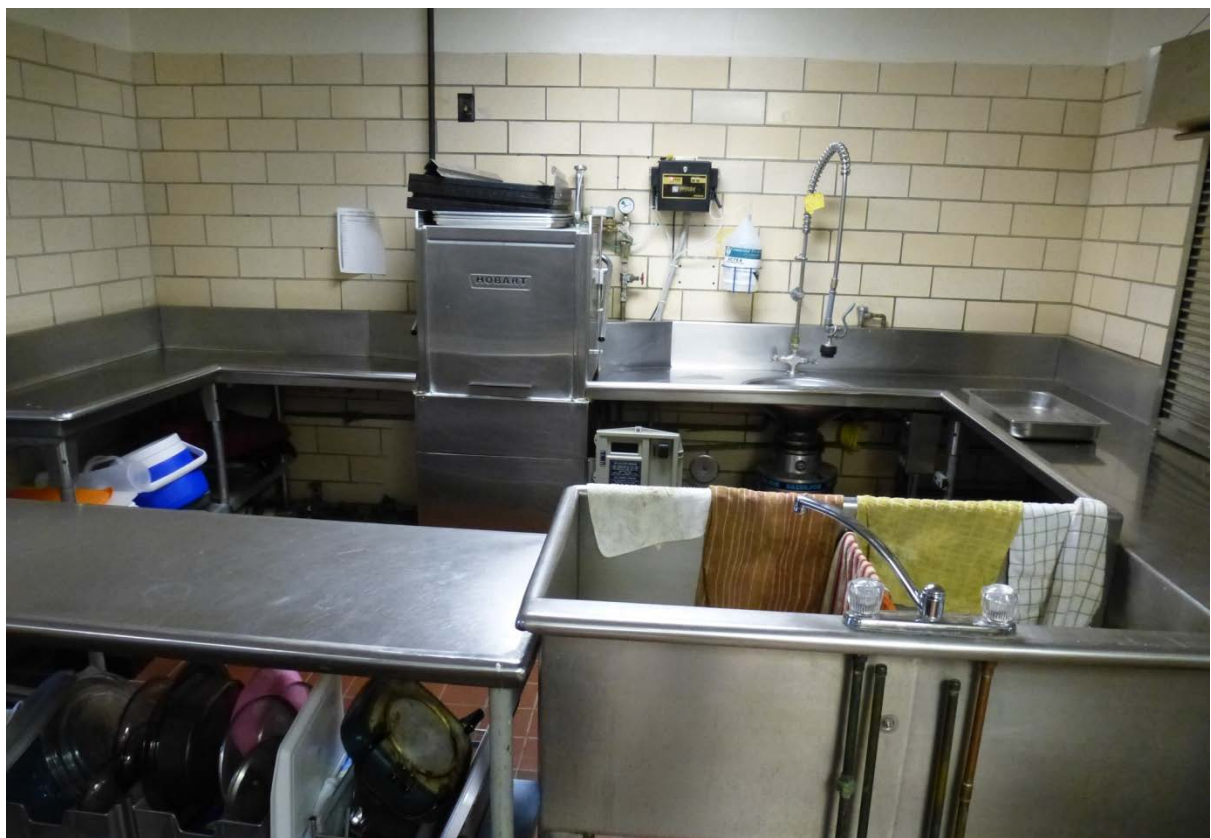
Photo 70. Kitchen with original glazed-tile floor and sanitary tile walls (original school) (ERDC-CERL, 2012).

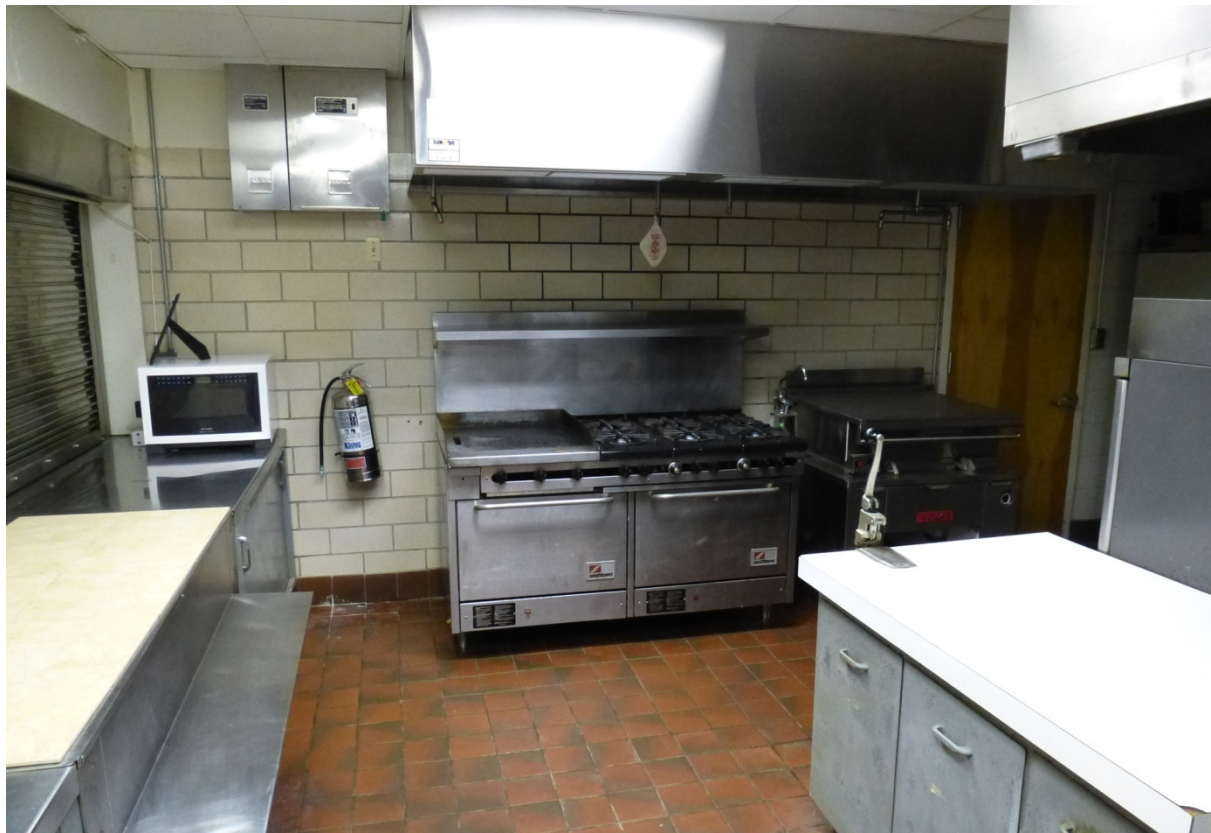
Photo 71. Kitchen with original glazed-tile floor and sanitary tile walls (original school) (ERDC-CERL, 2012).

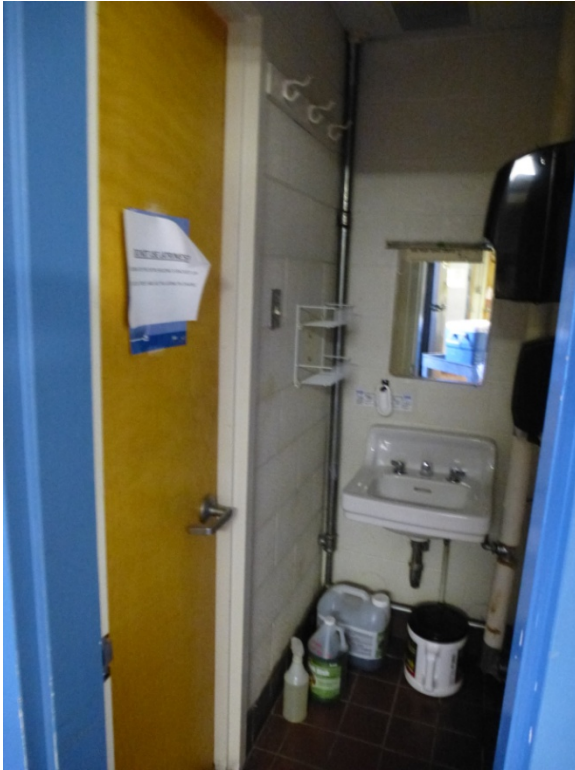
Photo 73. Original toilet room off of kitchen with replacement sink (original school) (ERDC-CERL, 2012).

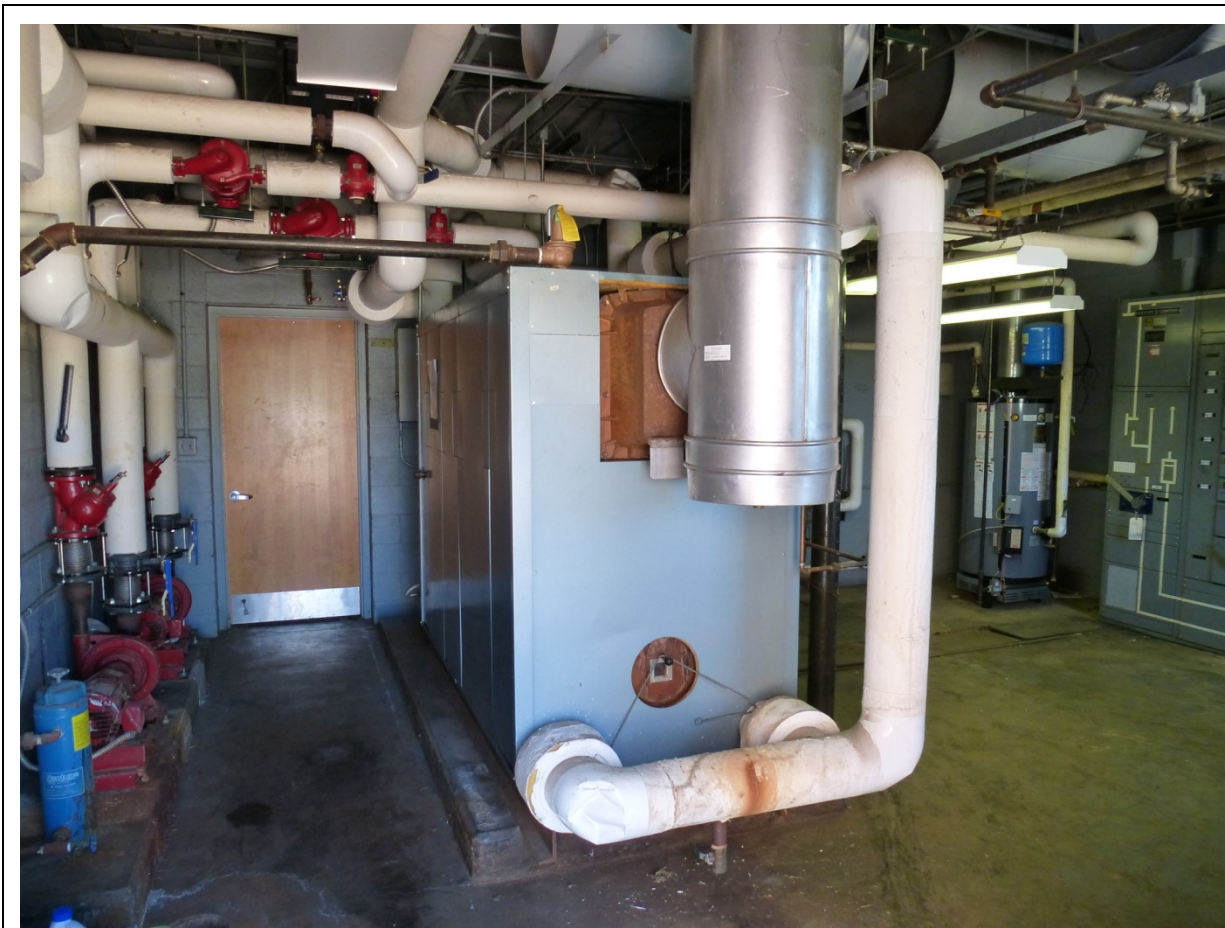
Photo 75. Boiler room (original school) (ERDC-CERL, 2012).

Boiler Room: The boiler room is part of the original school design and is located on the southwest corner of the original footprint. The boiler room is filled with mechanical equipment and has a concrete floor (photo 75). A replacement wood door provides access into the boiler room from the corridor. A replacement metal door provides access to the exterior, while a large replacement window/panel is located on the west wall of the boiler room.

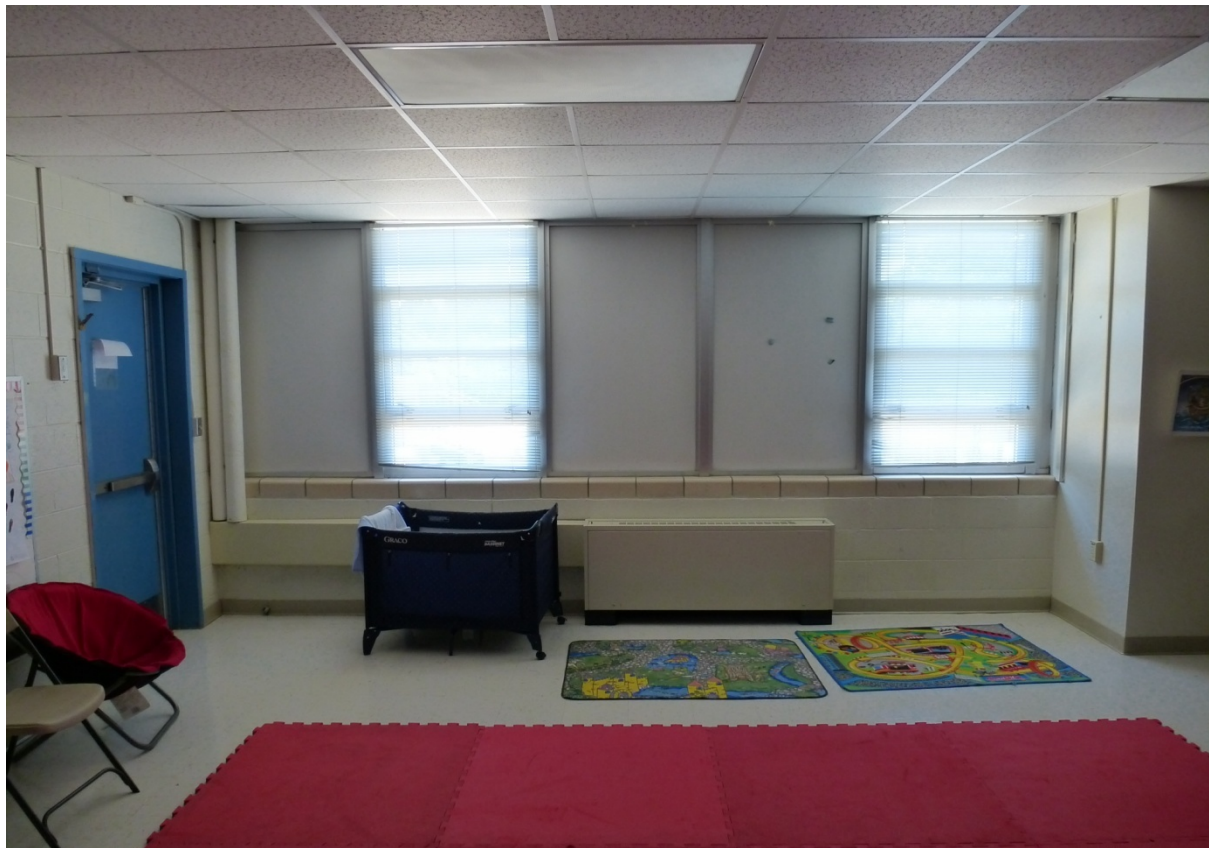
Photo 77. Interior of one of the kindergarten rooms with original windowsill (original school) (ERDC-CERL, 2012).

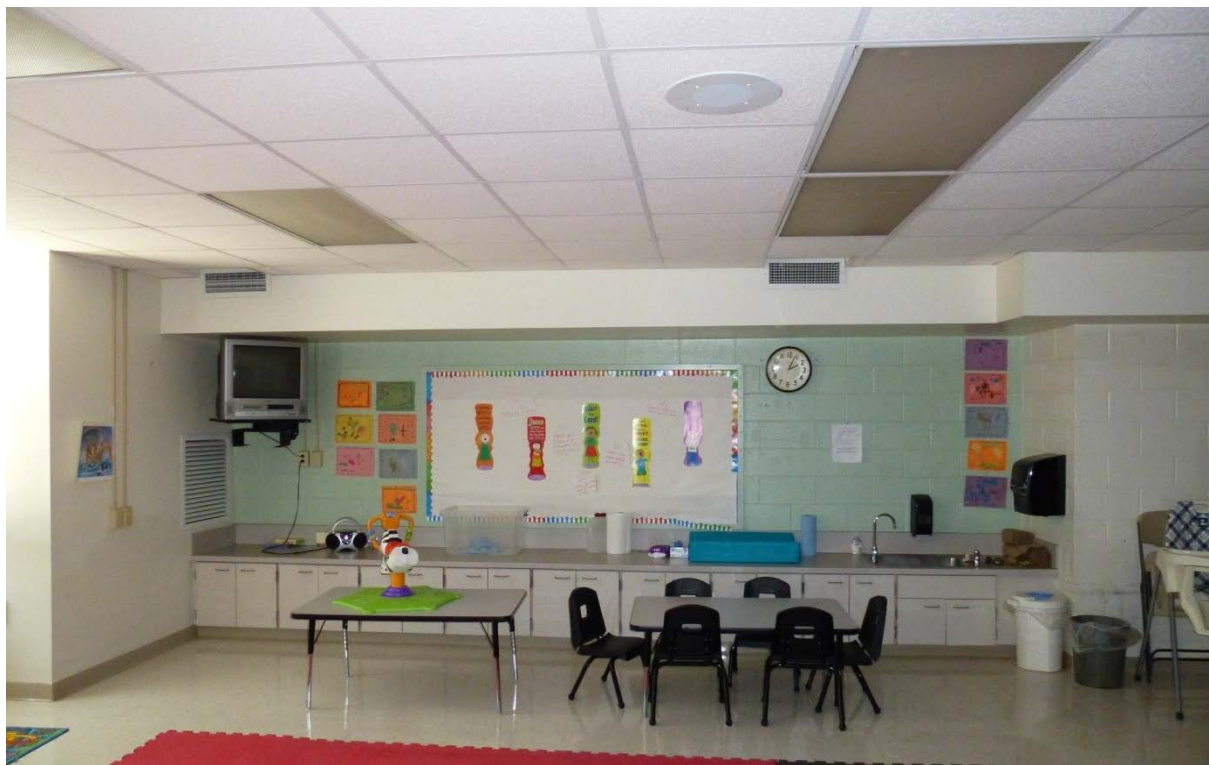
Photo 78. Interior of one of the kindergarten rooms looking toward original cabinets and workstation (original school) (ERDC-CERL, 2012).

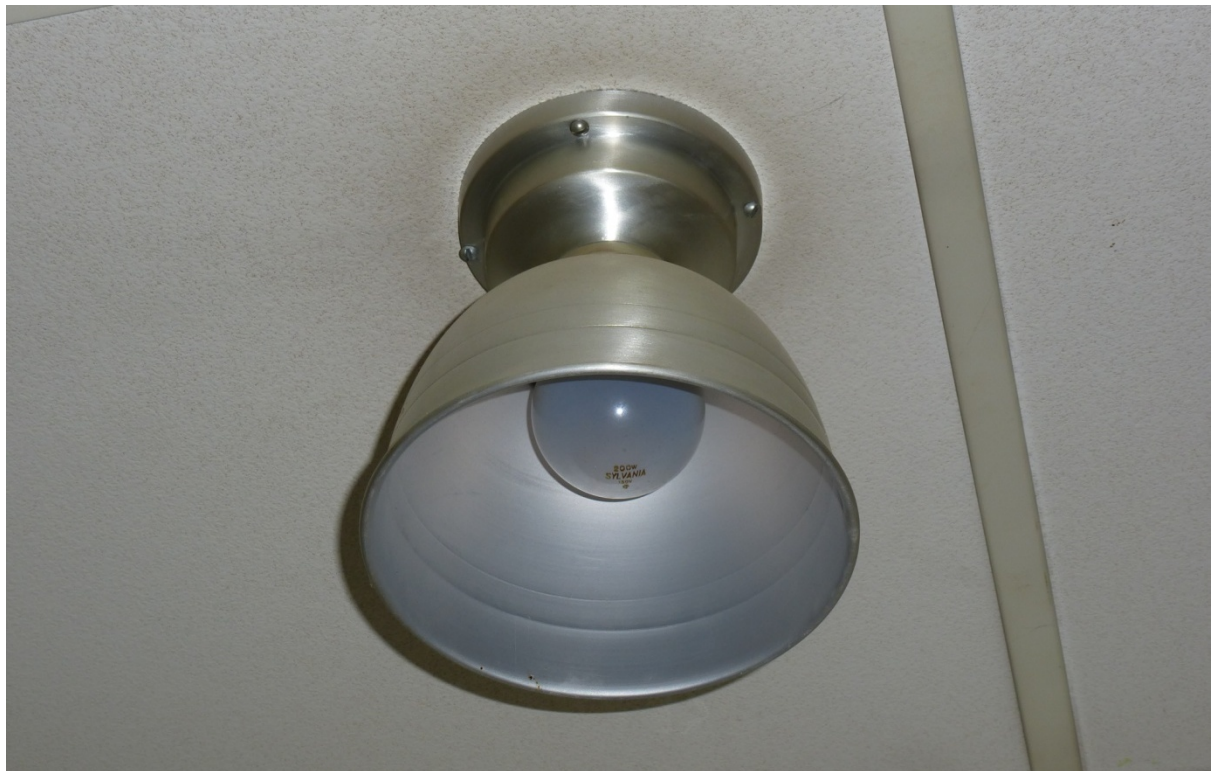
Photo 79. Older style light fixture in a kindergarten room (original school) (ERDC-CERL, 2012).

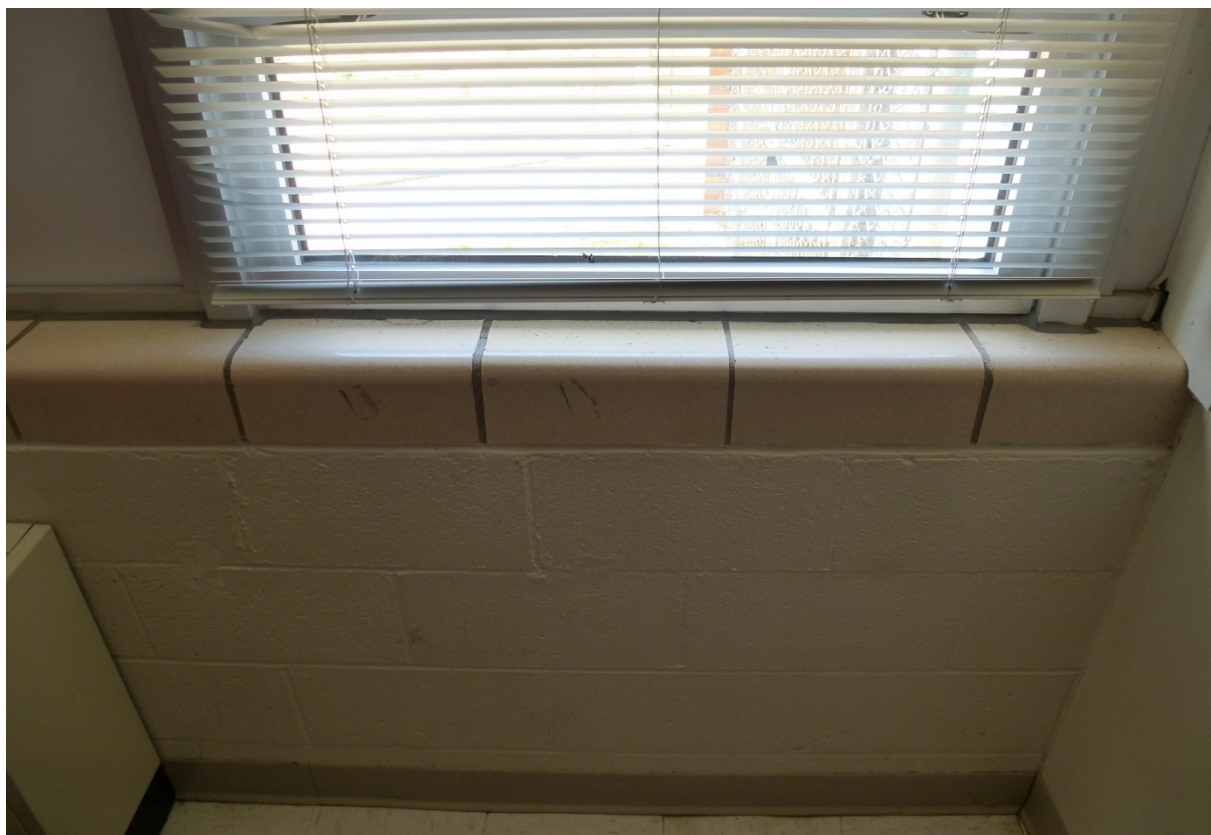
Photo 80. Original windowsill (original school) (ERDC-CERL, 2012).

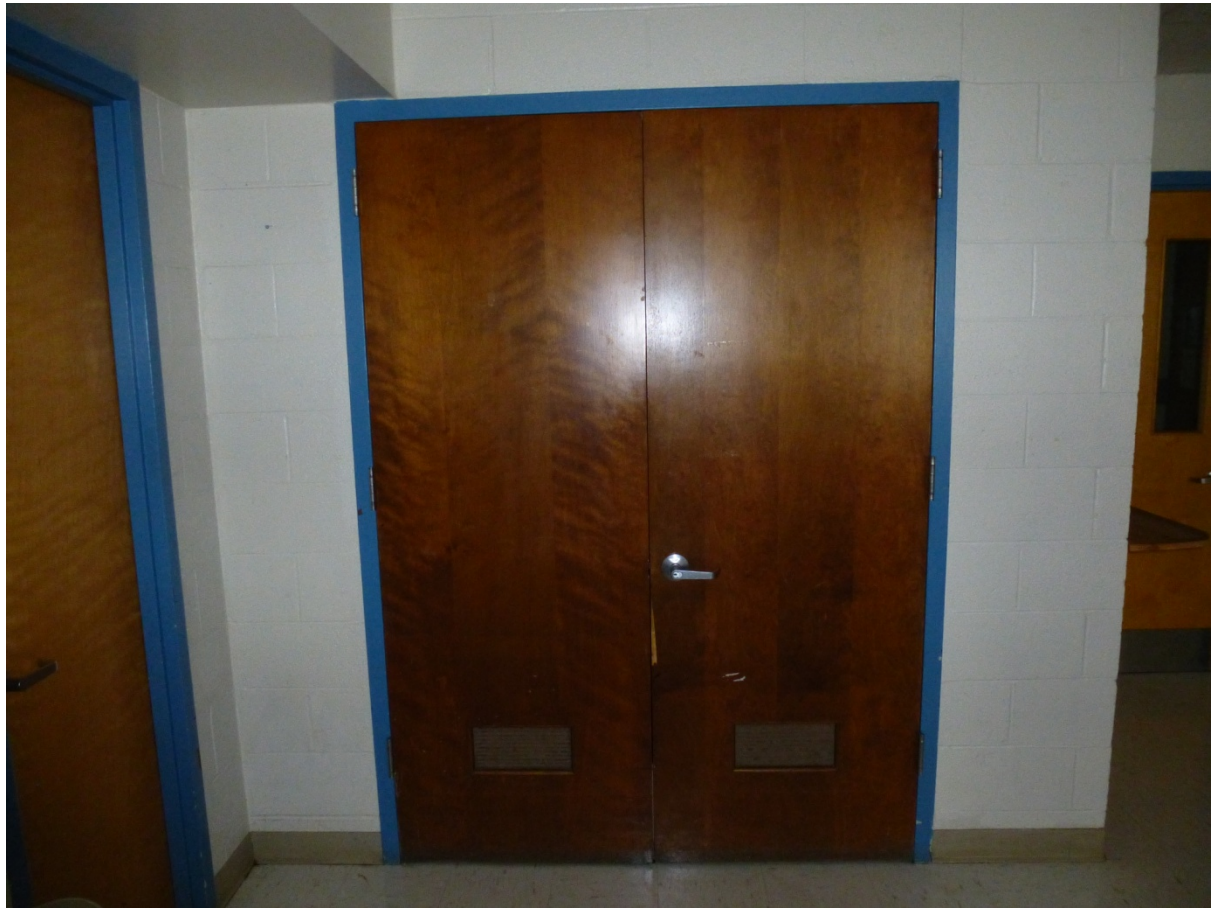
Photo 81. Original wood closet doors (original school) (ERDC-CERL, 2012).

Kindergarten Rooms: The two kindergarten rooms are slightly different than the other classrooms in the building. The two rooms are divided by a partition wall but connected via a toilet room (photo 82). The rooms each have two closets with original wood double doors (photo 81). One wall in each room is lined with original cabinets and workspace (photo 78). Each room has a replacement metal door that leads to the exterior (photos 77 and 83), and a single entry replacement wood door that provides access to the room from the corridor (photo 76). The rooms have replacement vinyl tile and replacement acoustic drop-tile ceilings.

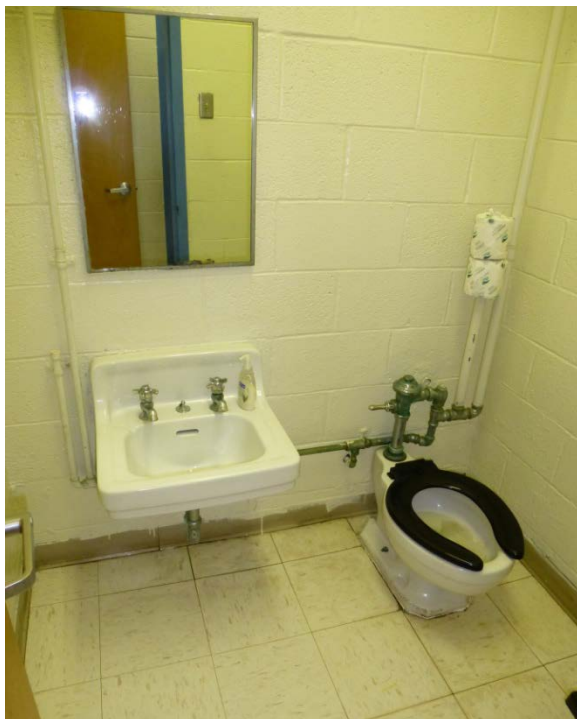
Photo 82. Original toilet room in between the two kindergarten rooms (original school) (ERDC-CERL, 2012).

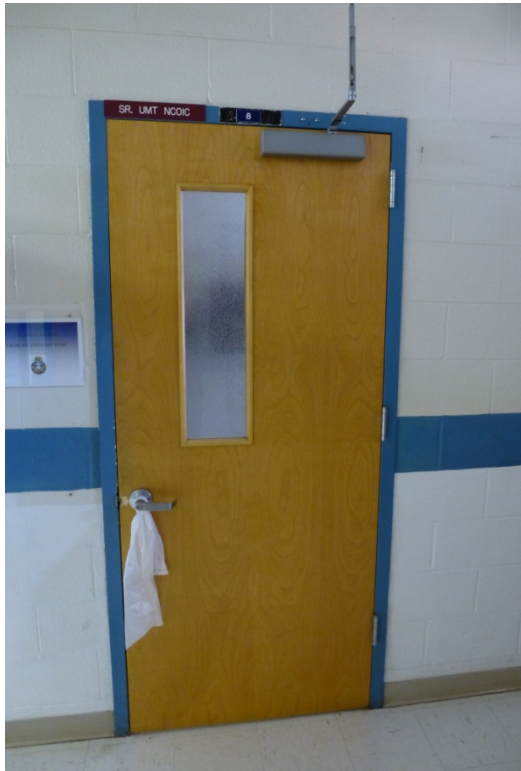
Photo 85. Replacement interior door (original school) (ERDC-CERL, 2012).

Teacher Workroom/Nurse Room: These rooms are now used as offices. Each room has a replacement vinyl tile flooring, acoustic drop-tile ceiling, replacement light fixtures, concrete block walls, and replacement wood entry doors that provide access from the corridor (photos 84 and 85).

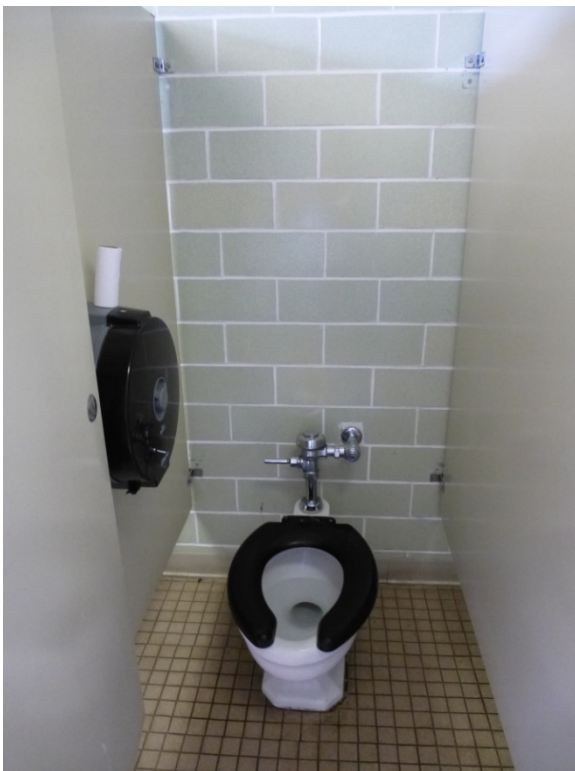
Photo 88. Girls' rest room with original toilets (original school) (ERDC-CERL, 2012).

Girls’ Restroom: The restroom consists of the original mosaic tile floor, original glazed-tile walls, and original toilets. There is a single replacement window located on the west wall (photos 86–88).

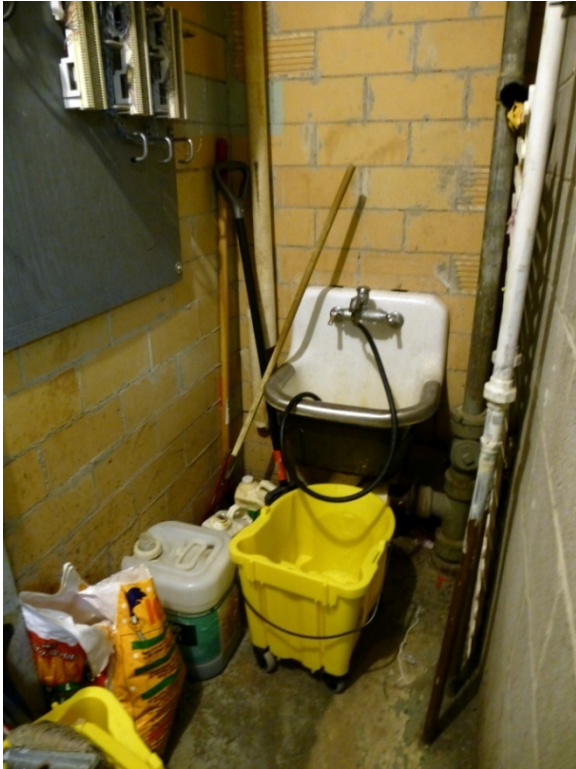
Photo 89. Janitor's closet between girls' and boys' restrooms with original mop sink (original school) (ERDC-CERL, 2012).

Janitor Room: The room is located between boys’ restroom and girls’ restroom on the west side of the building near the main entry. The room is small and consists of the original walls, concrete floor, and an original mop sink (photo 89).

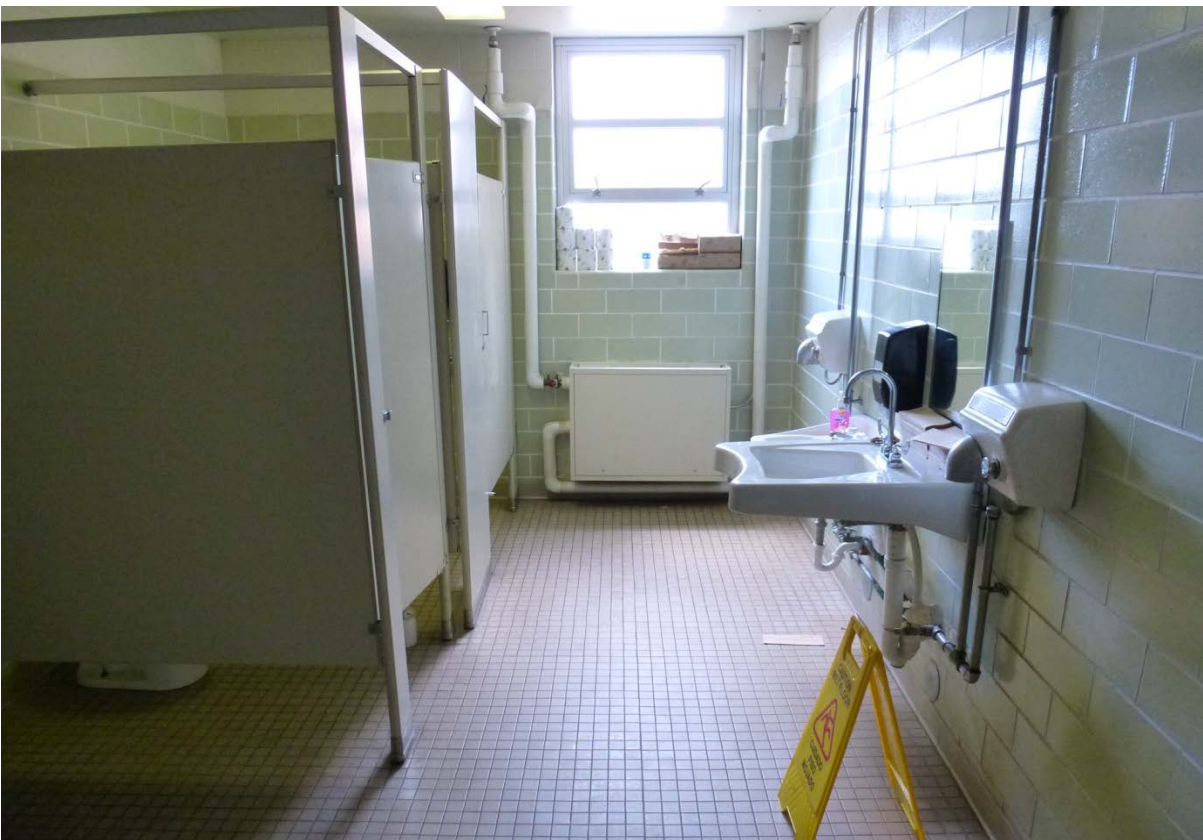
Photo 90. Boys' restroom with original glazed-tile walls (original school) (ERDC-CERL, 2012).

Boys’ Restroom: Restroom consists of the original mosaic tile floor, original glazed-tile walls, original urinals, and original toilets. There is a single replacement window located on the west wall (photo 90).

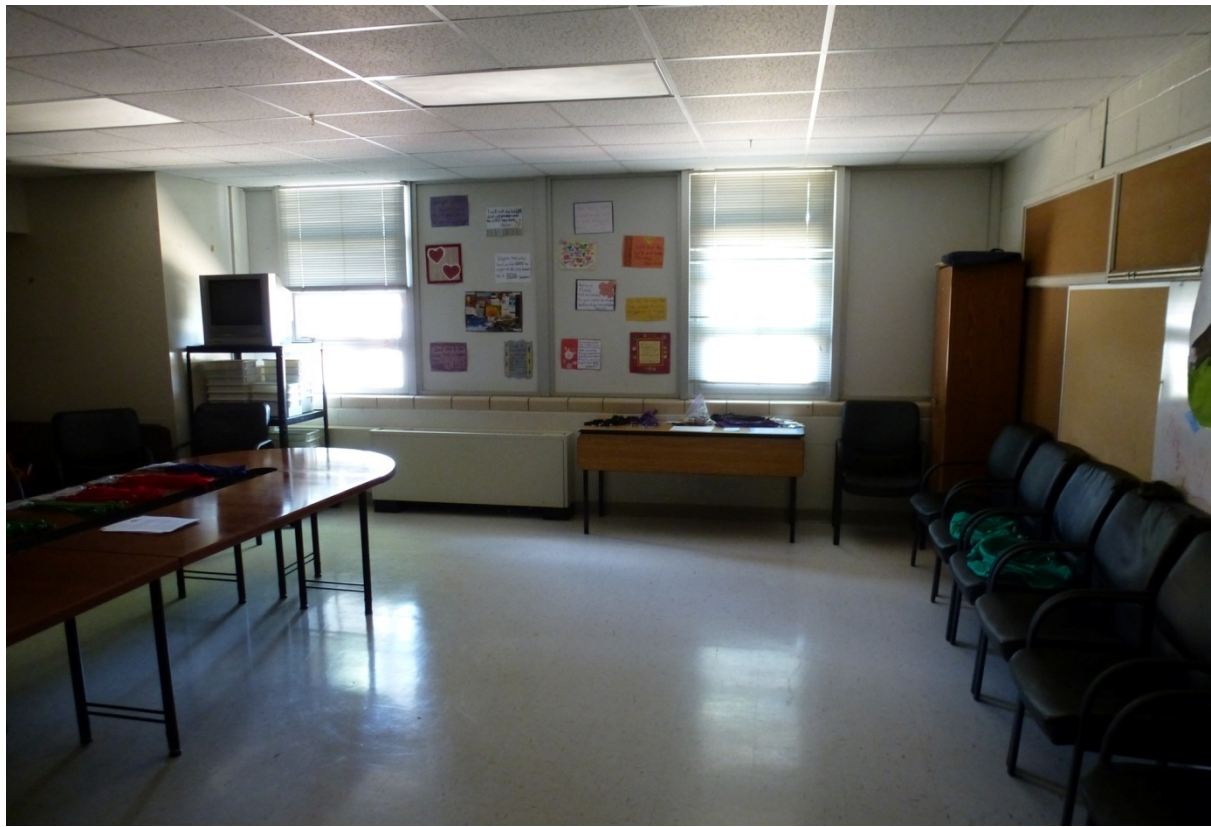
Photo 91. Classroom on west side of corridor (original school) (ERDC-CERL, 2012).

Classrooms: There are six classrooms intact as part of the original design of the school. Each classroom has replacement vinyl tile flooring, replacement acoustic drop-tile ceilings, replacement light fixtures, and replacement wood doors that provide access from the corridor to each classroom (photos 91, 94, and 97). Each classroom has a wall of metal panels and two windows with original glazed-tile windowsills (photo 91). The classrooms each have an original built-in wood wardrobe. The wardrobe is open with no doors; however, there is a small teacher’s closet adjacent to the wardrobe, and all of the original wood closet doors are intact (photos 92, 95, and 98). Along one wall in each classroom are the original wood chalkboard frames.

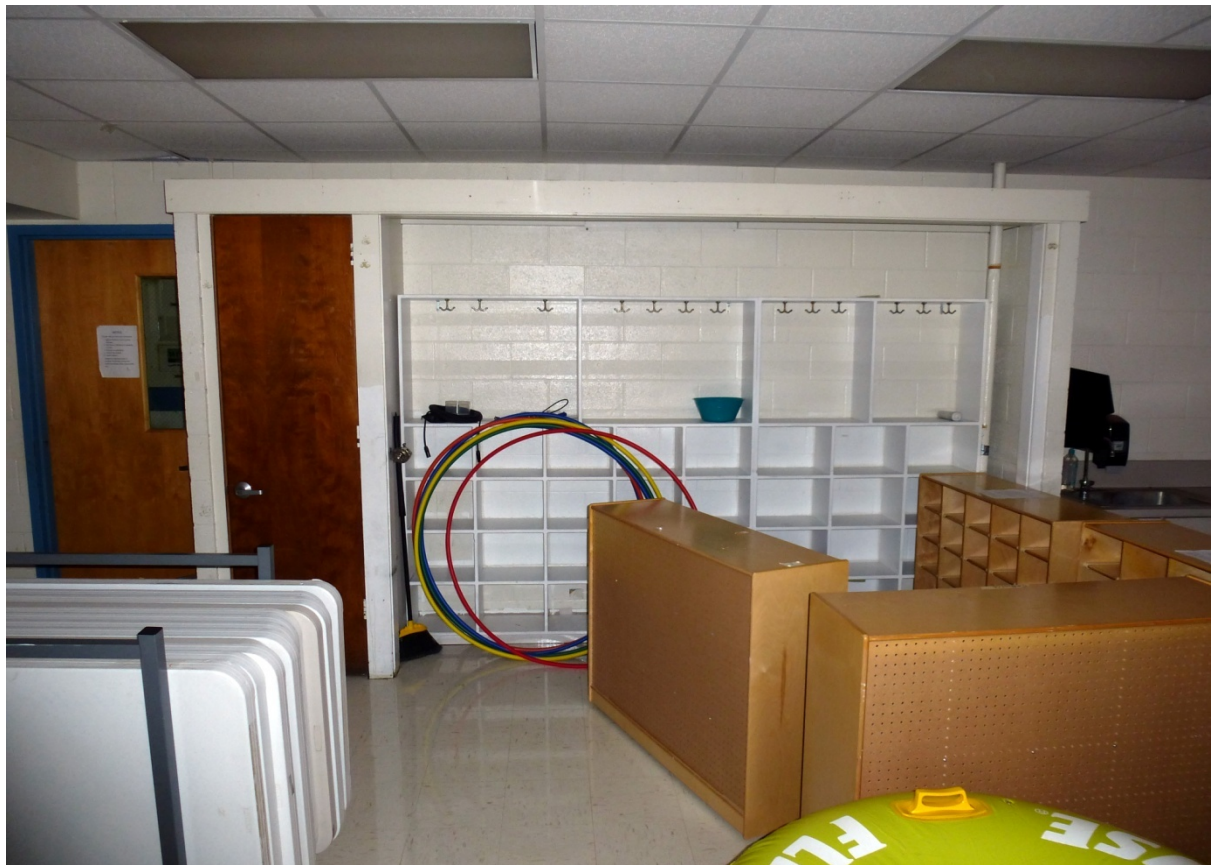
Photo 95. Original wardrobe and closet door (original school) (ERDC-CERL, 2012).

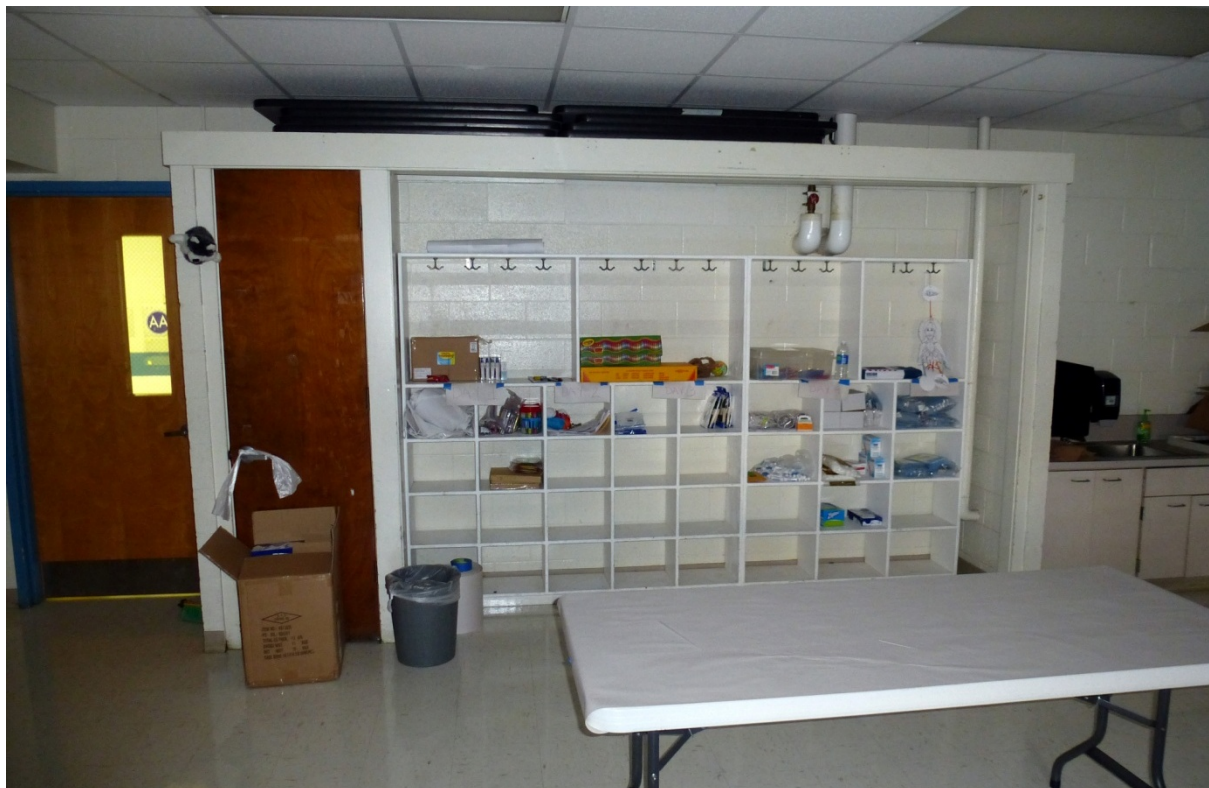
Photo 98. Original wardrobe with original closet door in a classroom (original school) (ERDC-CERL, 2012).

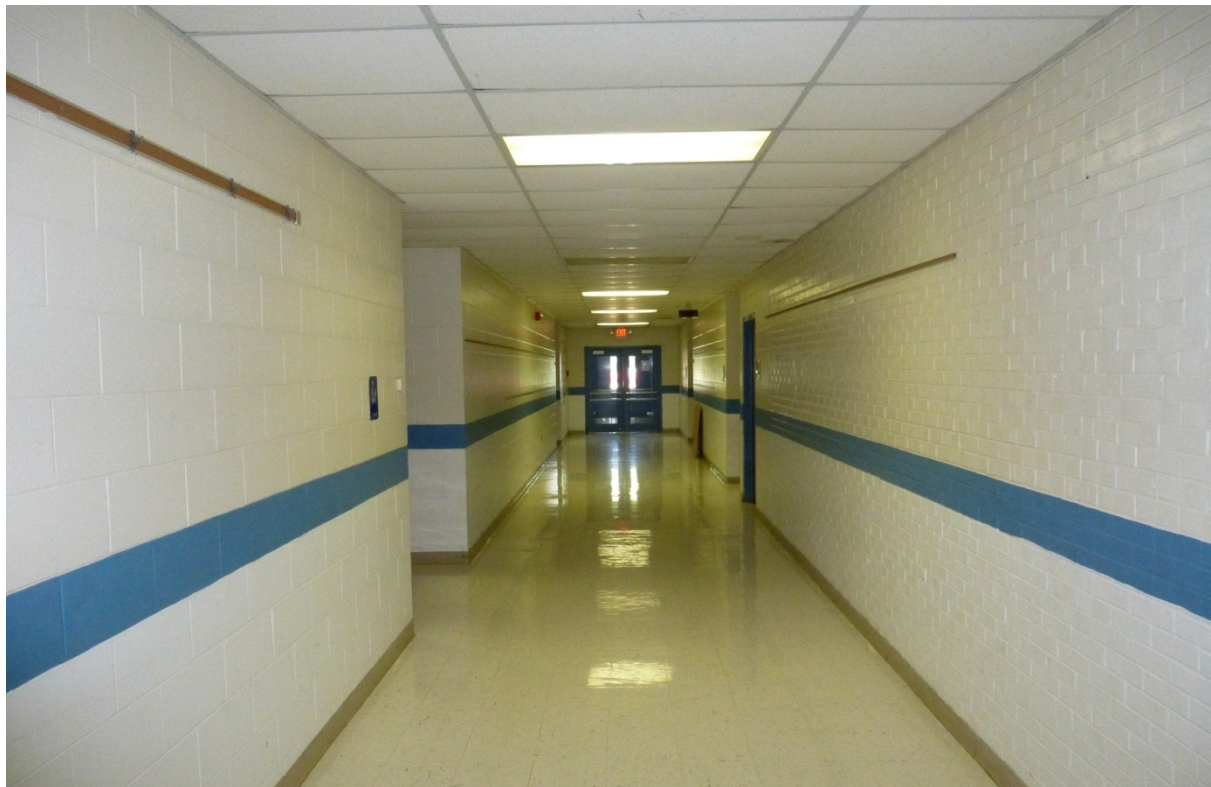
Photo 100. Looking north down corridor of 1984 addition (ERDC-CERL, 2012).

Corridors: The 1984 corridor stretches east off the intersection of the 1955/1957 connection point (photos 100 and 101). The corridor has acoustical drop-tile ceilings, concrete block walls, and vinyl tile floors (photo 59).

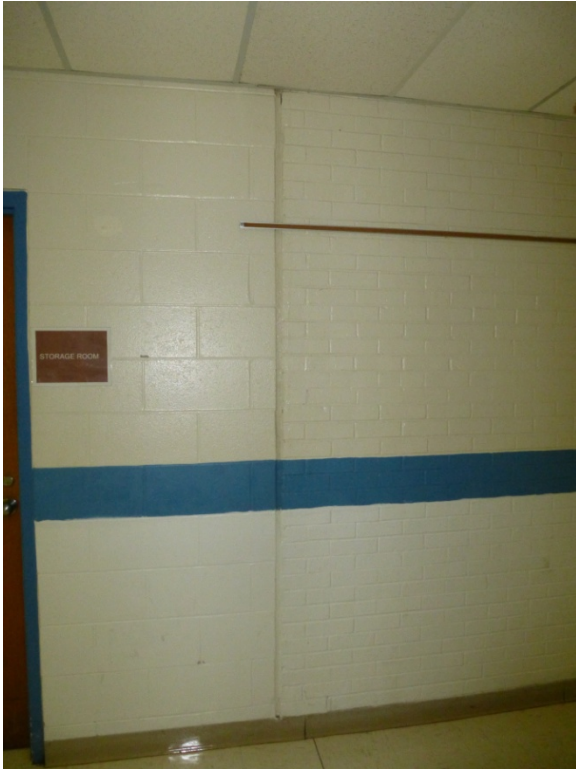
Photo 101. Closeup of connection between the original brick exterior wall and concrete block wall (1984 addition) (ERDC-CERL, 2012).

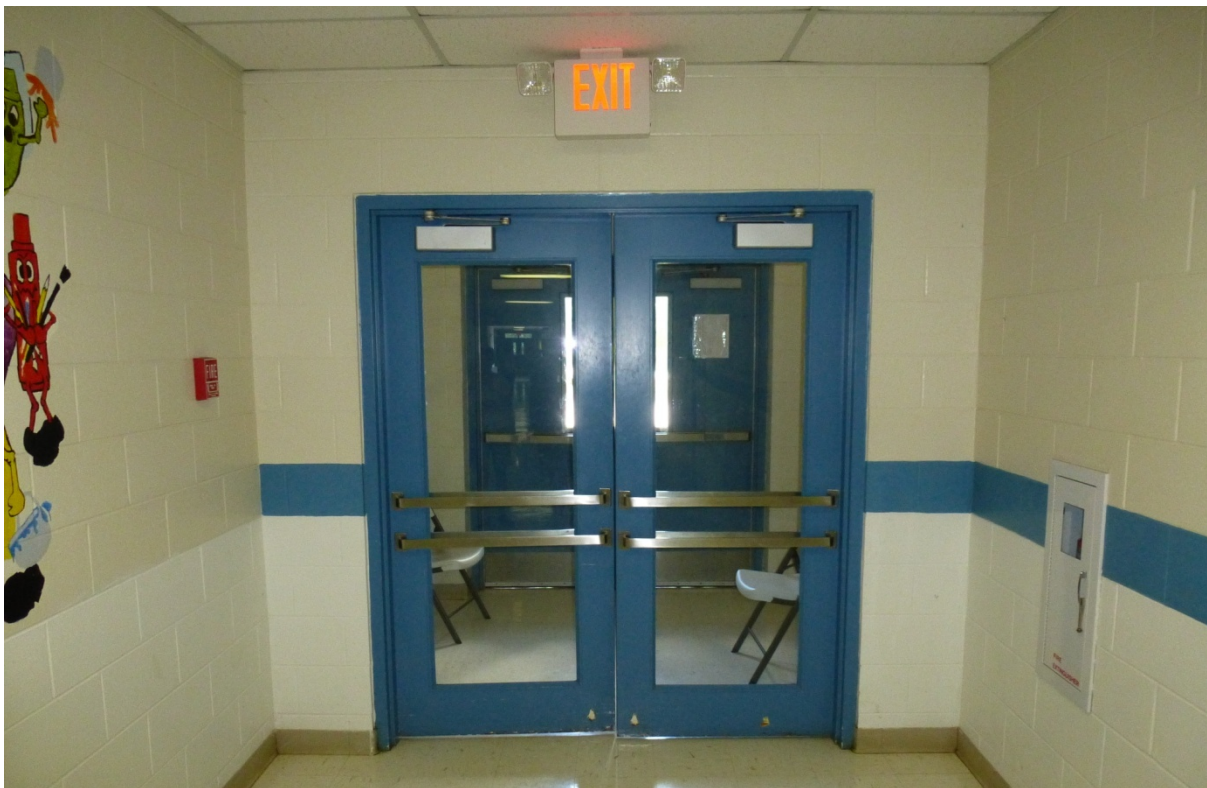
Photo 102. Older style vestibule doors located on the east end of the 1984 addition corridor (ERDC-CERL, 2012).

Vestibule on the east entry (This vestibule is part of the 1984 addition.): The vestibule has older-style metal doors with bright metal hardware (Photos 102 and 103). These doors are more appropriate to the age of the school but according to the drawings, these were not original to the design. The floor has been replaced and is currently covered with vinyl tiles.

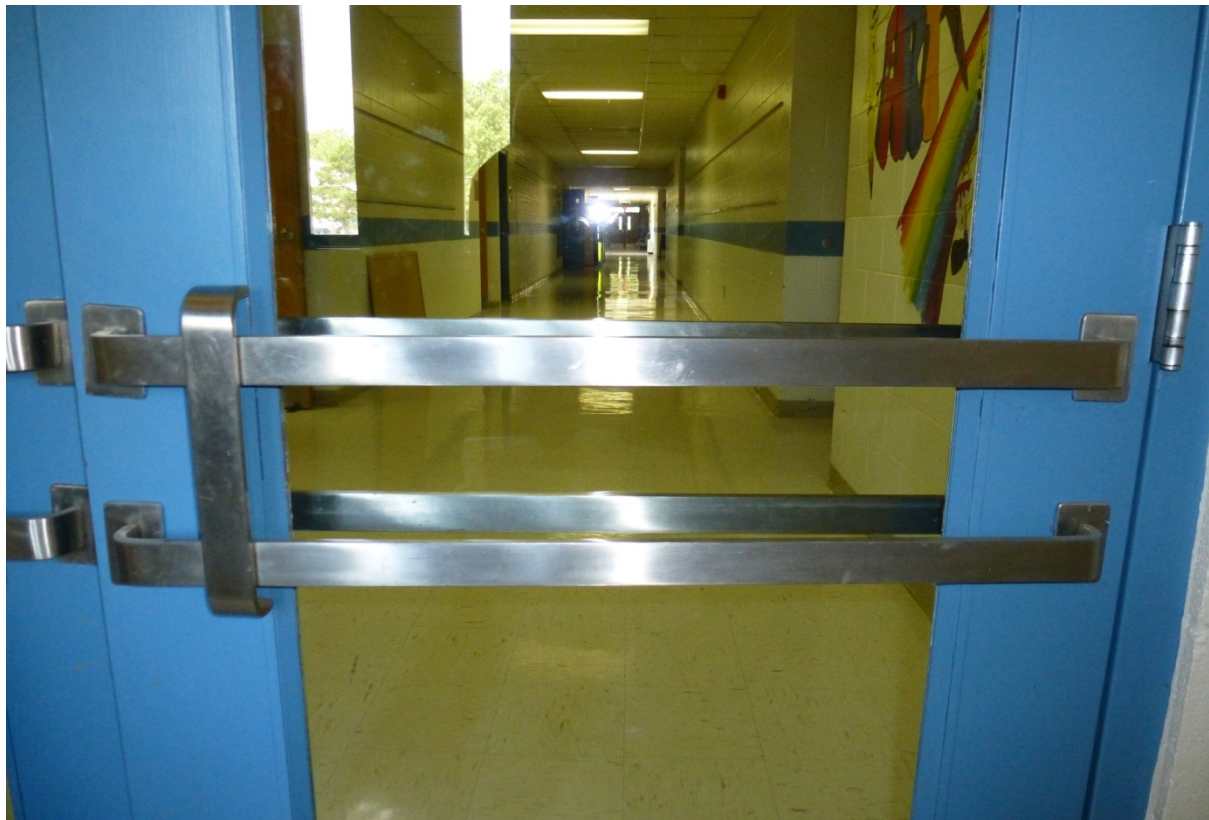
Photo 103. Closeup of older style vestibule door hardware (1984 addition) (ERDC-CERL, 2012).

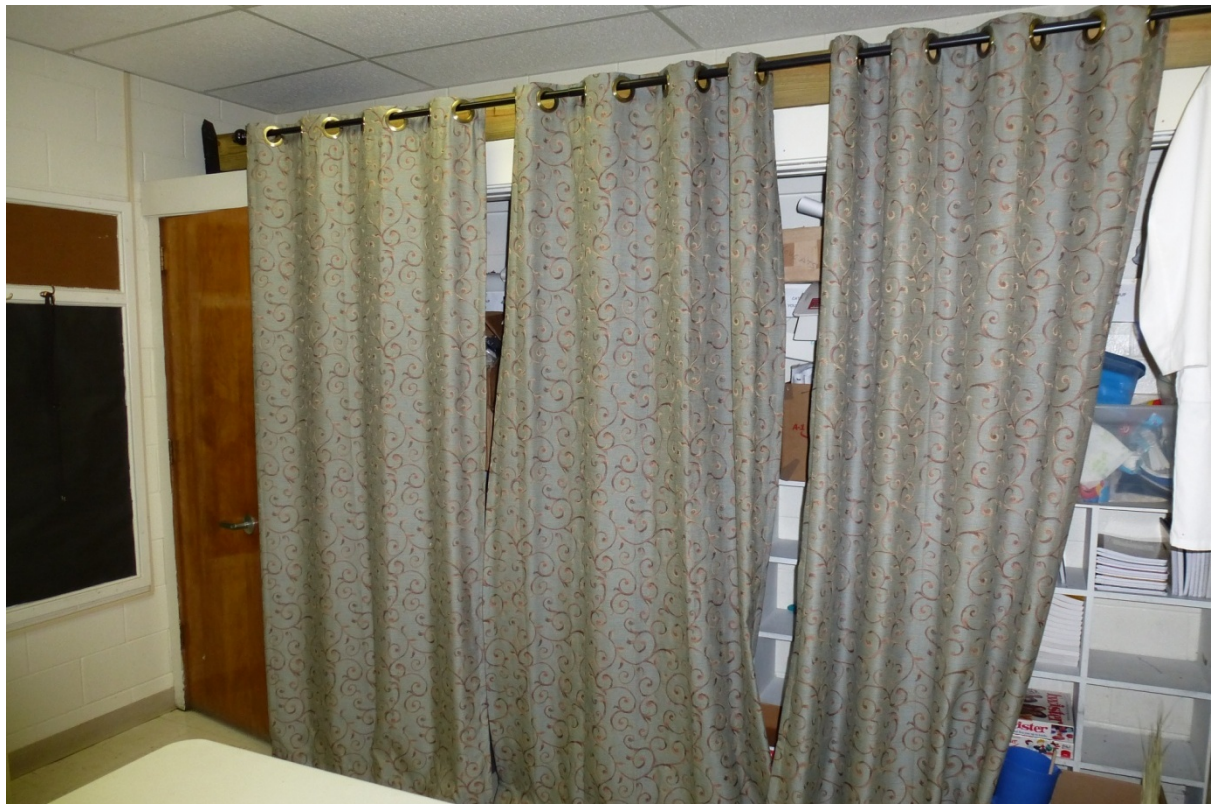
Photo 114. Wardrobe and closet door in classroom (1957 addition) (ERDC-CERL, 2012).

Classrooms: There were originally ten classrooms designed and constructed as part of the 1957 addition; however, with the construction of the 1984 addition, there are only nine classrooms intact. The design and construction of these classrooms are similar to the original 1955 classrooms. Each classroom has replacement vinyl tile flooring, replacement acoustic drop-tile ceilings, replacement light fixtures, and replacement wood doors that provide access from the corridor to each classroom (photos 113 and 115). Each classroom has a wall of a combination of metal panels and two windows with original glazed-tile windowsills (photos 109 and 132). The classrooms each have an original built-in wood wardrobe. The wardrobe is open with no doors; however, there is a small teacher's closet adjacent to the wardrobe and all of the original wood closet doors are intact (photos 108, 112, 114, 116, 126, 128, and 133). Along one wall in each classroom are the original wood chalkboard frames.
